Storm-Tide Elevations Produced by Hurricane Andrew Along the Southern Florida Coasts, August 24, 1992

Open-File Report 94-116

By MITCHELL H. MURRAY

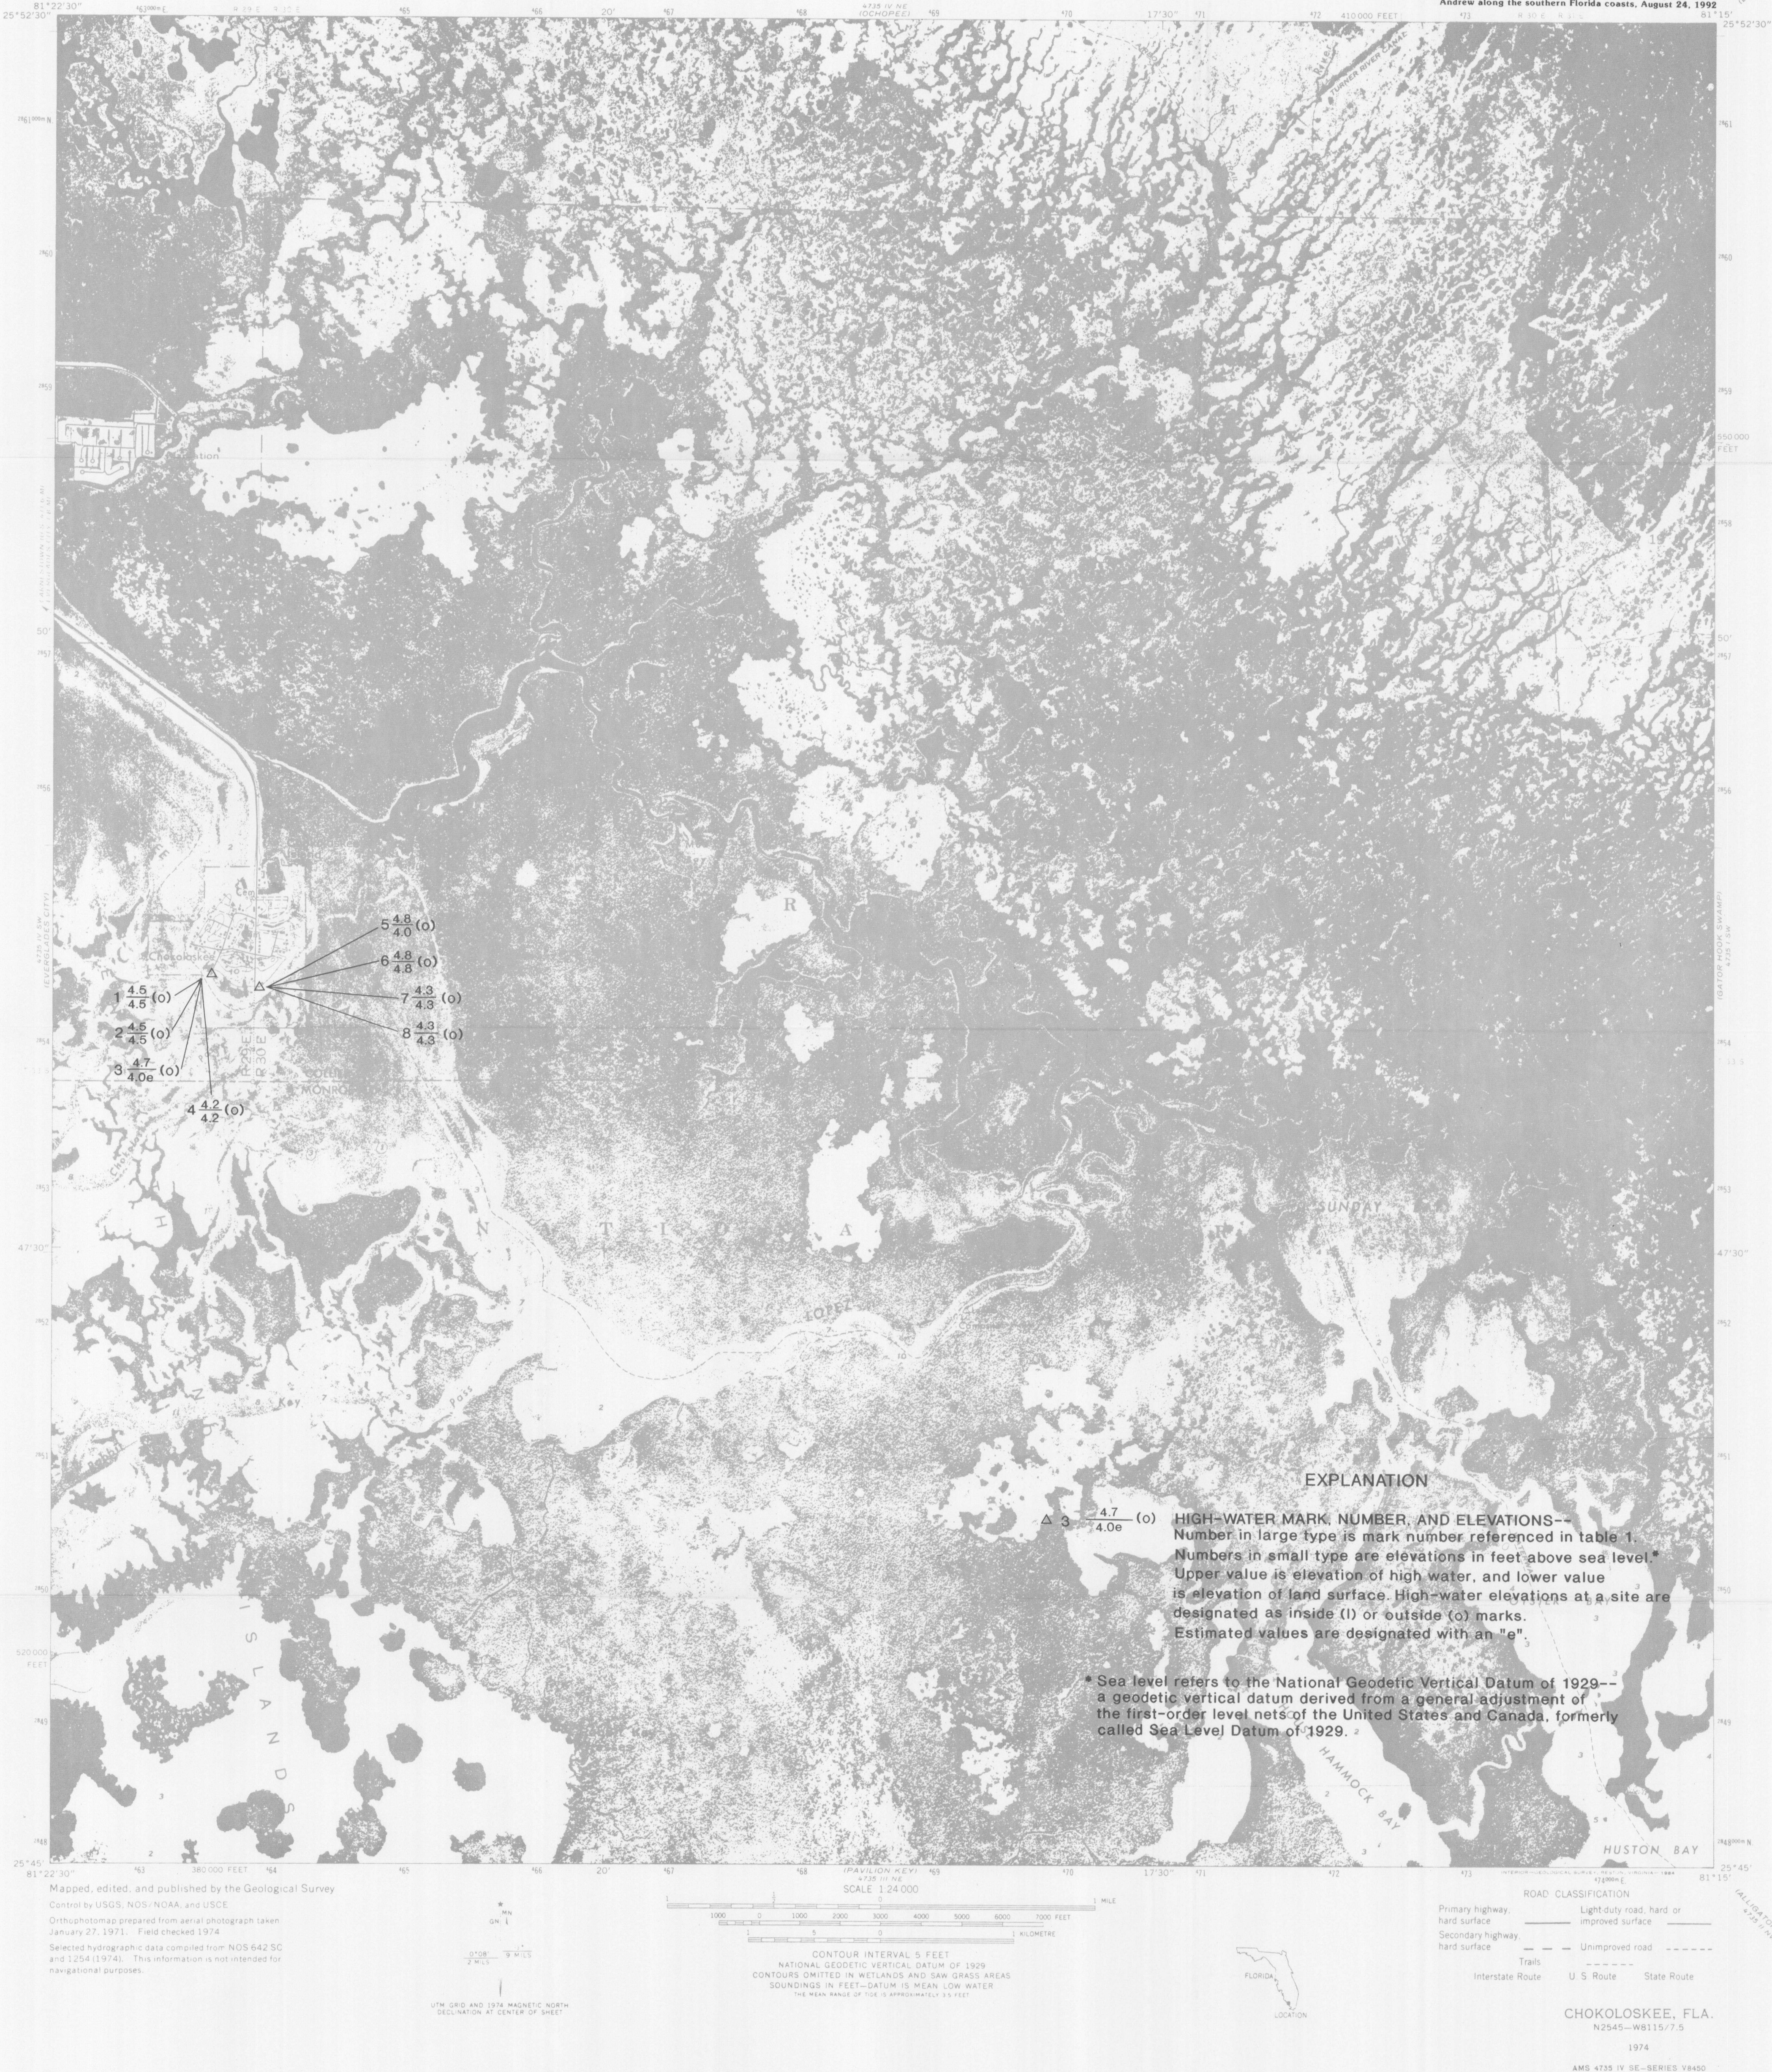
PLATE 18.--MAP SHOWING WATER-SURFACE ELEVATIONS AND HIGH-WATER MARK LOCATIONS IN AREAS AFFECTED BY HURRICANE ANDREW, CHOKOLOSKEE, FLORIDA, QUADRANGLE.

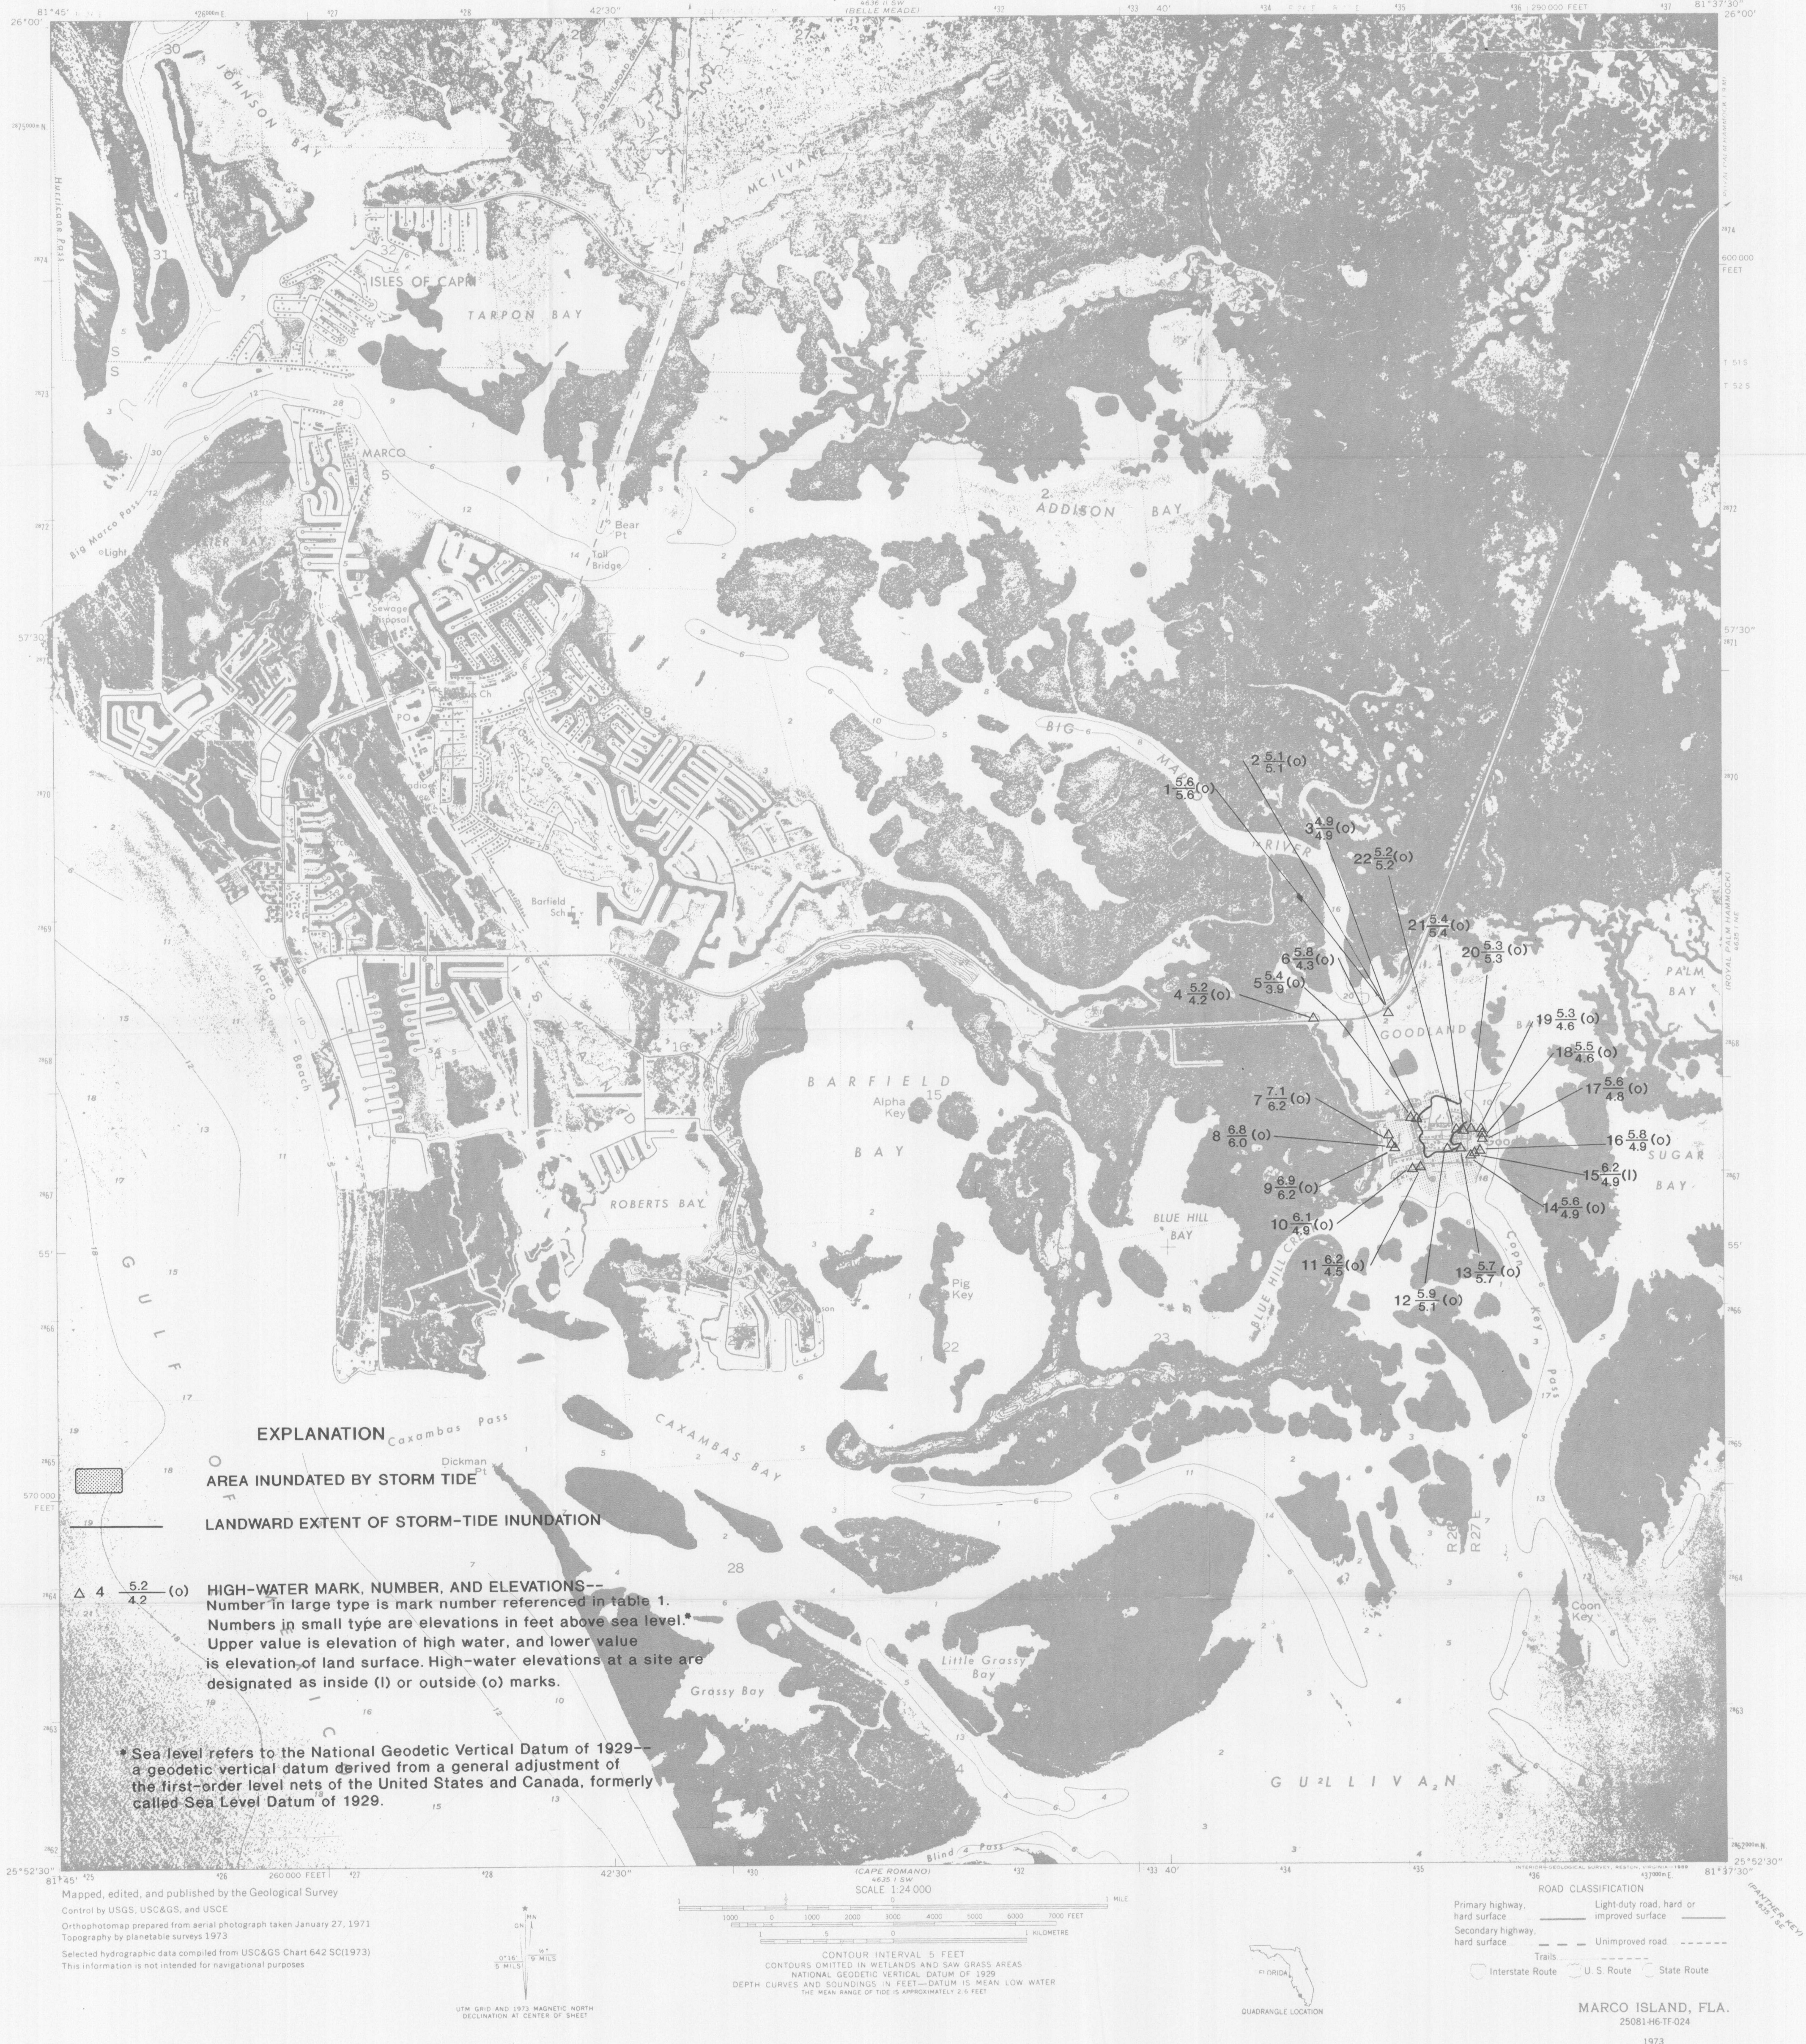
PLATE 19.--MAP SHOWING WATER-SURFACE ELEVATIONS, HIGH-WATER MARK LOCATIONS, AND LANDWARD EXTENT OF STORM-TIDE INUNDATION IN AREAS AFFECTED BY HURRICANE ANDREW, MARCO ISLAND, FLORIDA, QUADRANGLE.

as S.W. 107th Avenue (pl. 5). Many areas south of Princeton Canal were also inundated, but control in these areas was limited because of inaccessibility of the areas (pl. 7). Elliot and Adams Keys were completely inundated (pl. 8). Goodland in the northern part of the Ten Thousand Islands area was partly inundated, but storm tides were not noticeably above normal high tide at Marco Island Beach, in the area west of David Key and north of Caxambas Bay, or at the Isle of Capri (pl. 19).
